Progress M-27M Mission Updates

Flawed Separation System blamed for Loss of Progress M-27M Craft

Many open Questions remain in Progress M-27M Failure Investigation

Progress M-27M Failure Investigation focuses on Soyuz Rocket

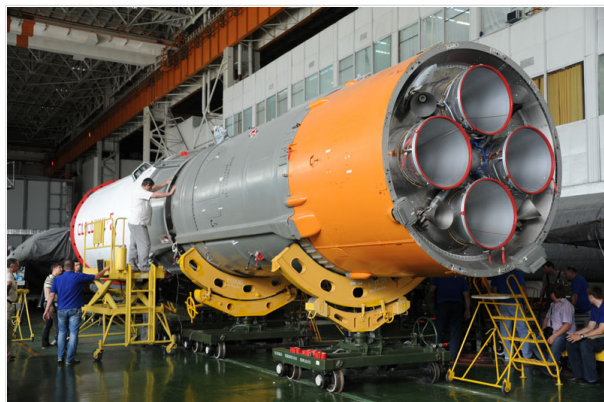
Soyuz Block I Stage

The disintegration of the third stage can explain the damage suffered by the Progress and the amount of debris seen in orbit. Roscosmos said that the findings were still preliminary and a number of simulations and hardware experiments were still ongoing.

Russian sources reported that one possible explanation for the failure of the third stage oxidizer tank was **a fault introduced during manufacture** (<http://novosti-kosmonavtiki.ru/forum/messages/forum10/topic14472/message1379301/#message1379301>) the forward bulkhead of the tank was welded to the cylindrical section of the tank. In this particular case, two welds were made between the central cylinder and the bulkhead where normally a single weld is sufficient. The disintegration of the LOX tank could have explained the presence of an axial force shortly after engine cutoff and the energy released when the forward bulkhead became detached would have been capable of propelling the 3rd stage and spacecraft into vastly different orbits.

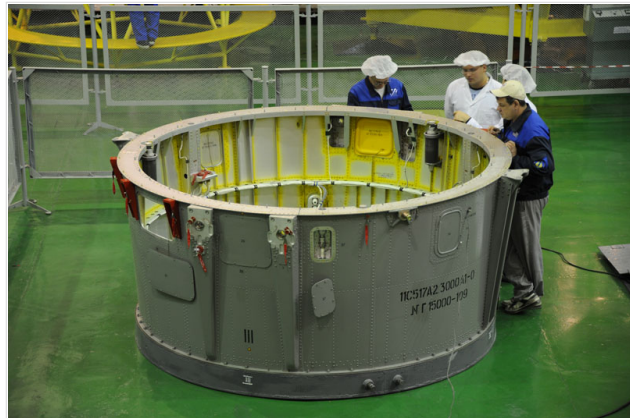
Progress M-M Payload Adapter & Separation System

In the Roscosmos statement issued on Monday, the agency announced that the likely culprit in the Progress M-27M failure lies within a design flaw in the spacecraft separation system and associated frequency-dynamic characteristics. According to the State Commission, these properties were not fully studied as part of the design work that went into the accommodation of Soyuz and Progress spacecraft atop the Soyuz 2-1A rocket.

No exact details were given by Roscosmos with respect to the design peculiarity associated with the frequency oscillations observed within the separation mechanism. In October, [the first Progress craft to launch aboard Soyuz 2-1A \(/progress-m-25m-mission-updates.html\)](#) enjoyed a seemingly flawless ride into orbit, with no problems at separation – raising the question on what was different between the successful Progress M-25M launch and the failed M-27M mission.

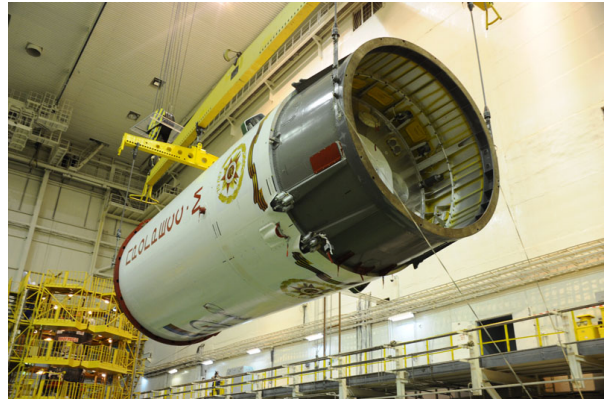
Progress Payload Adapter & Separation Interface

Evidence points to an explosion occurring on the Block-I stage, leading to the destruction of the communications equipment of the third stage and ejecting debris that punctured propellant lines or tanks on the Progress spacecraft, leading to the depressurization of one of two propellant manifolds on the spacecraft.

The venting fuel and/or pressurant is suspected to be the culprit in the observed body rates on the Progress, but it is also possible that the explosion on the third stage sent the stack into a tumble before the spacecraft was separated.

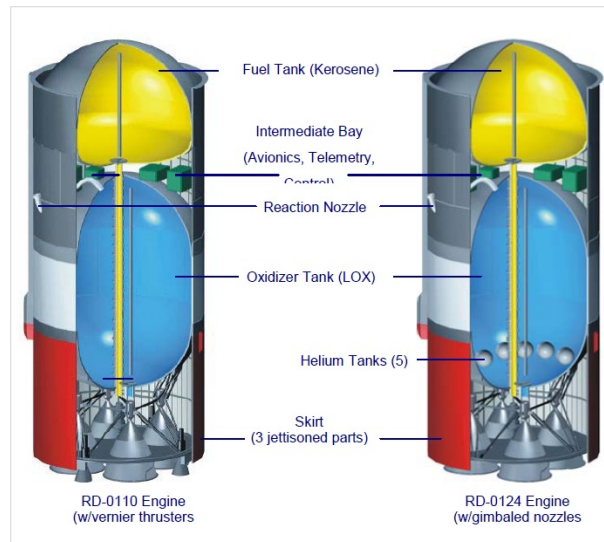
Soyuz 2 Third Stage Design

The communications equipment of the Block I stage is located in the intertank compartment between the LOX and Kerosene tank, making it vulnerable in the event of a tank rupture or explosion. The simultaneous drop-out of communications from both channels can certainly be explained by an explosion of the third stage and so could the discrepancy in the initial insertion orbit as an exploding tank could easily send the Progress into a higher orbit.

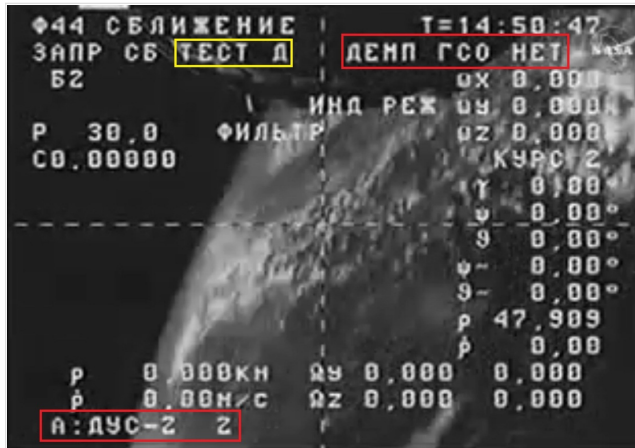
KURS Failure Messages

It took Progress a little under 80 minutes to complete almost an entire orbit and arrive back within range of Russian ground stations, but the news was not good. Telemetry from the spacecraft was not usable and the status of the Progress could not be confirmed, but a short blip of video was acquired of the KURS Navigation System Display which showed the KURS System in its nominal B1 Free Flight Mode, but also indicating two warnings: Loss of Attitude Control and an urgent failure message displayed to operators.
